## STABILIZATION OF LOWRY RUINS

ADRIAN S. WHITE  
AND  
DAVID A. BRETERNITZ

Mesa Verde Research Center  
University of Colorado  
Boulder, Colorado

March 1976

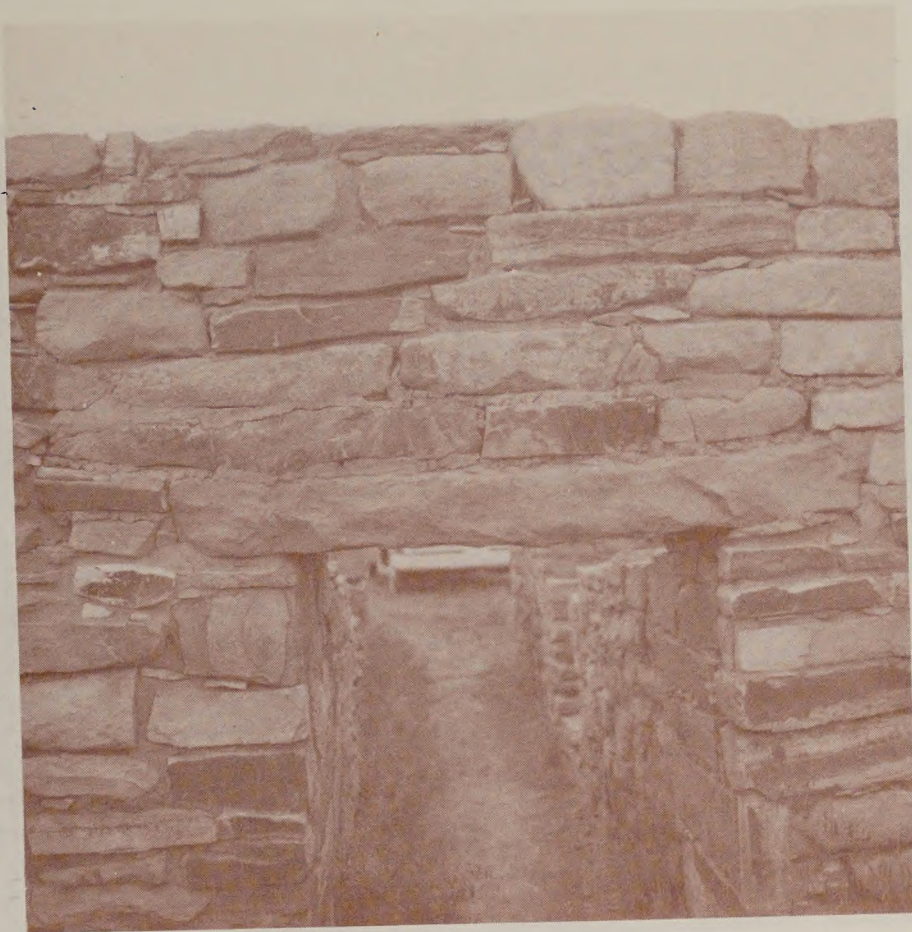
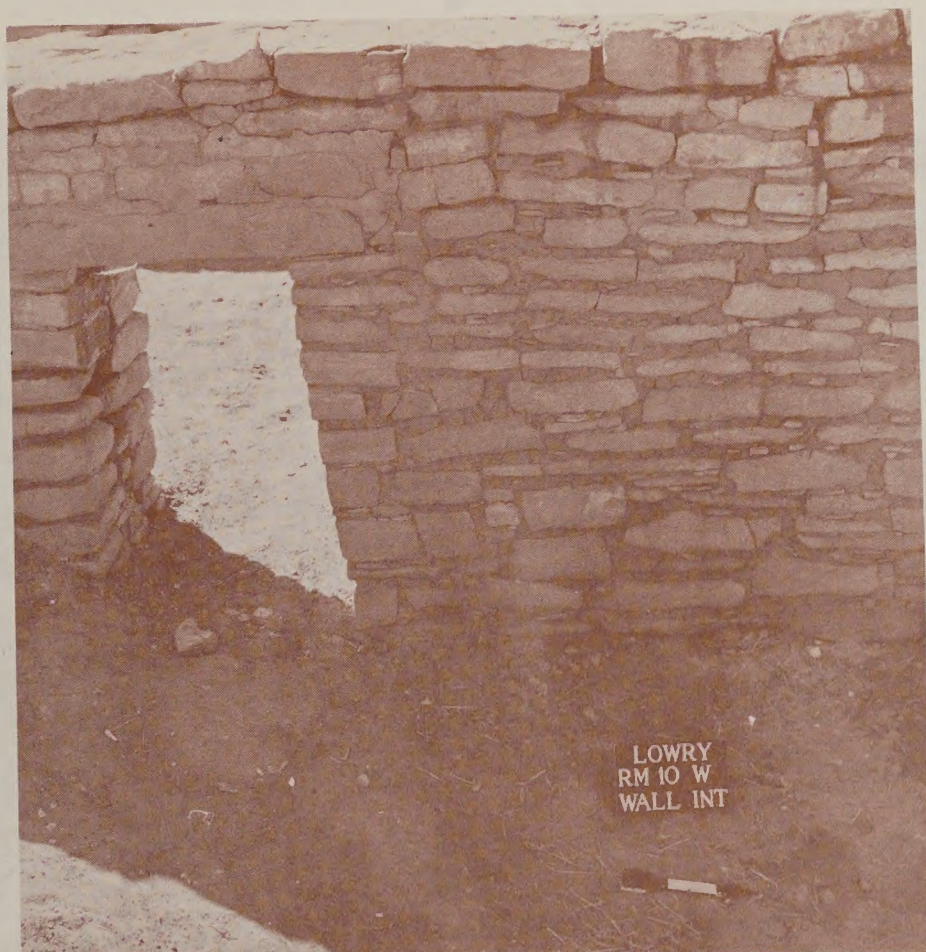
Figure 5. Doorways stabilized by Ben Williford, 1936. a, Room 10, east doorway; b, Room 10, west doorway.

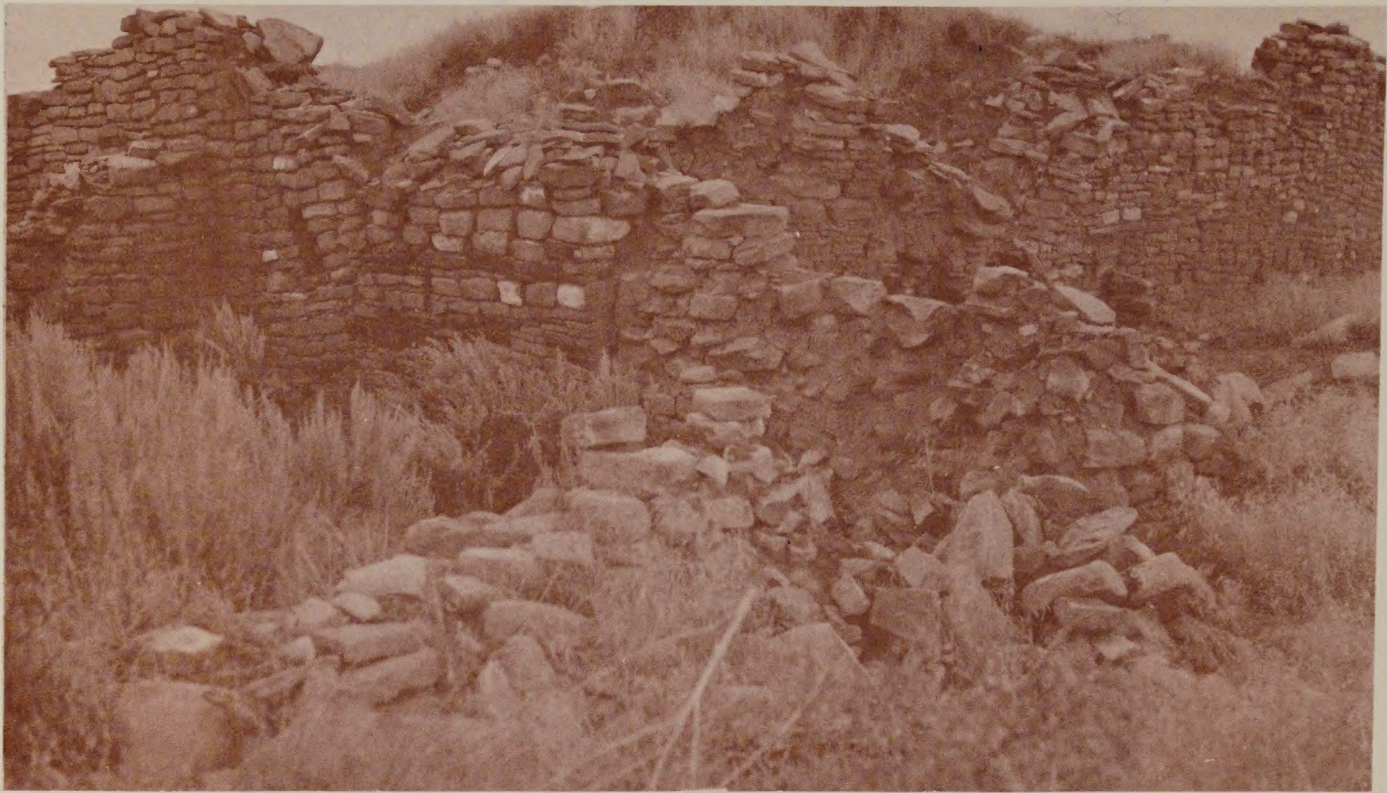
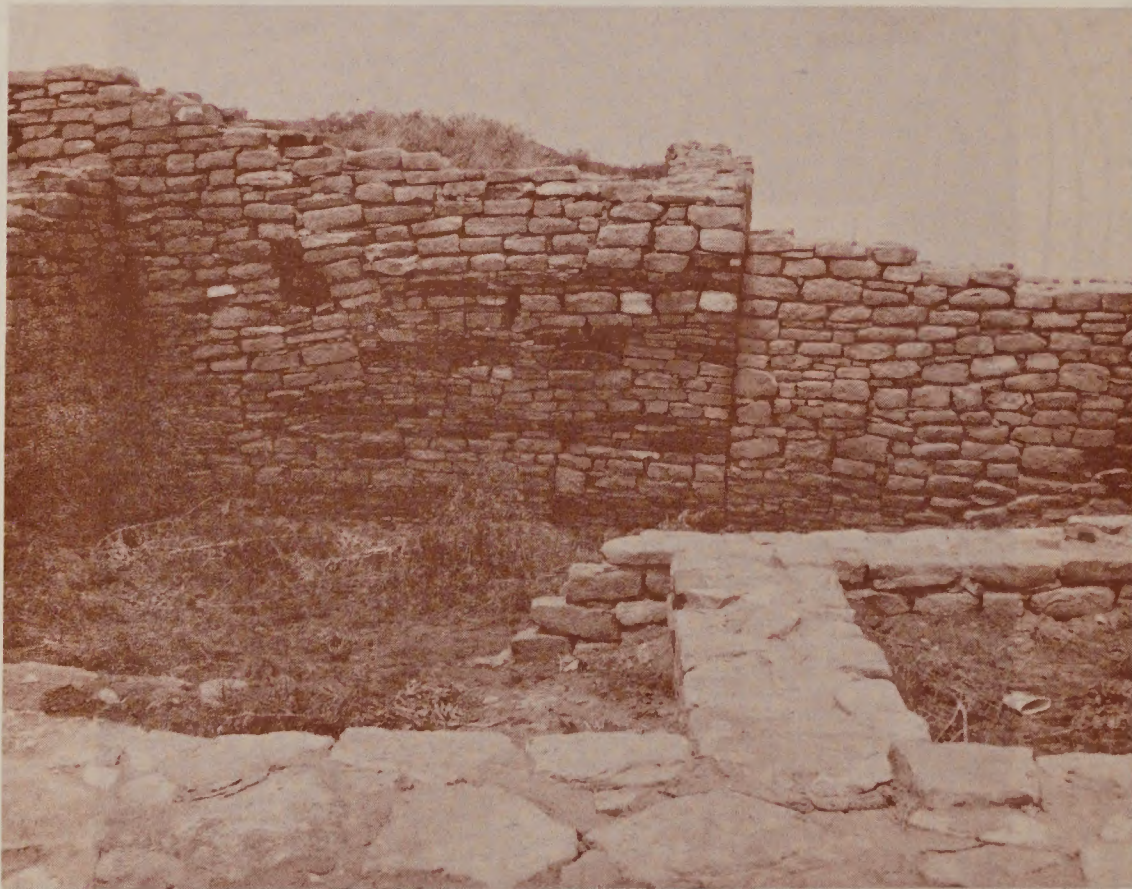
Figure 6. Room 9, north exterior wall, 1966. a, before stabilization; b, after stabilization.

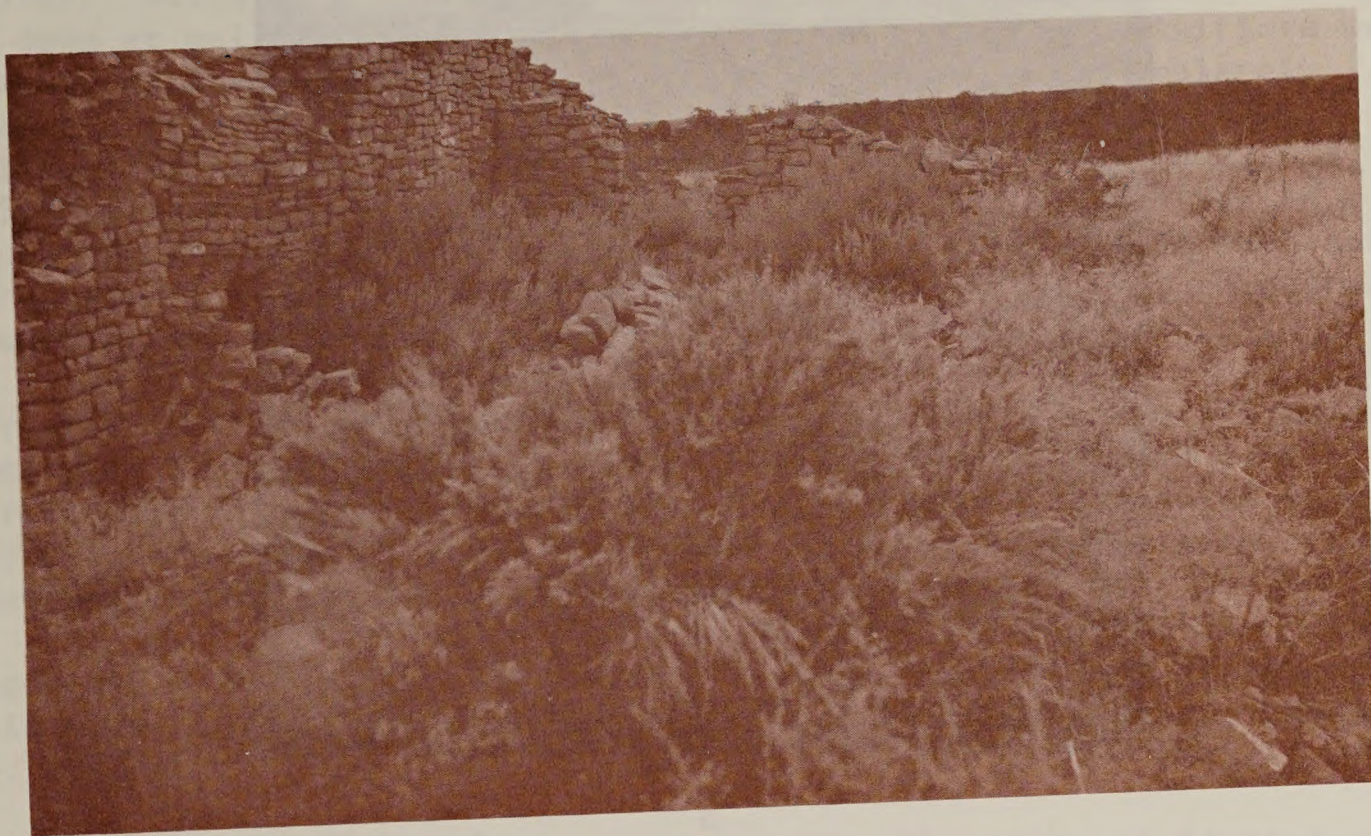
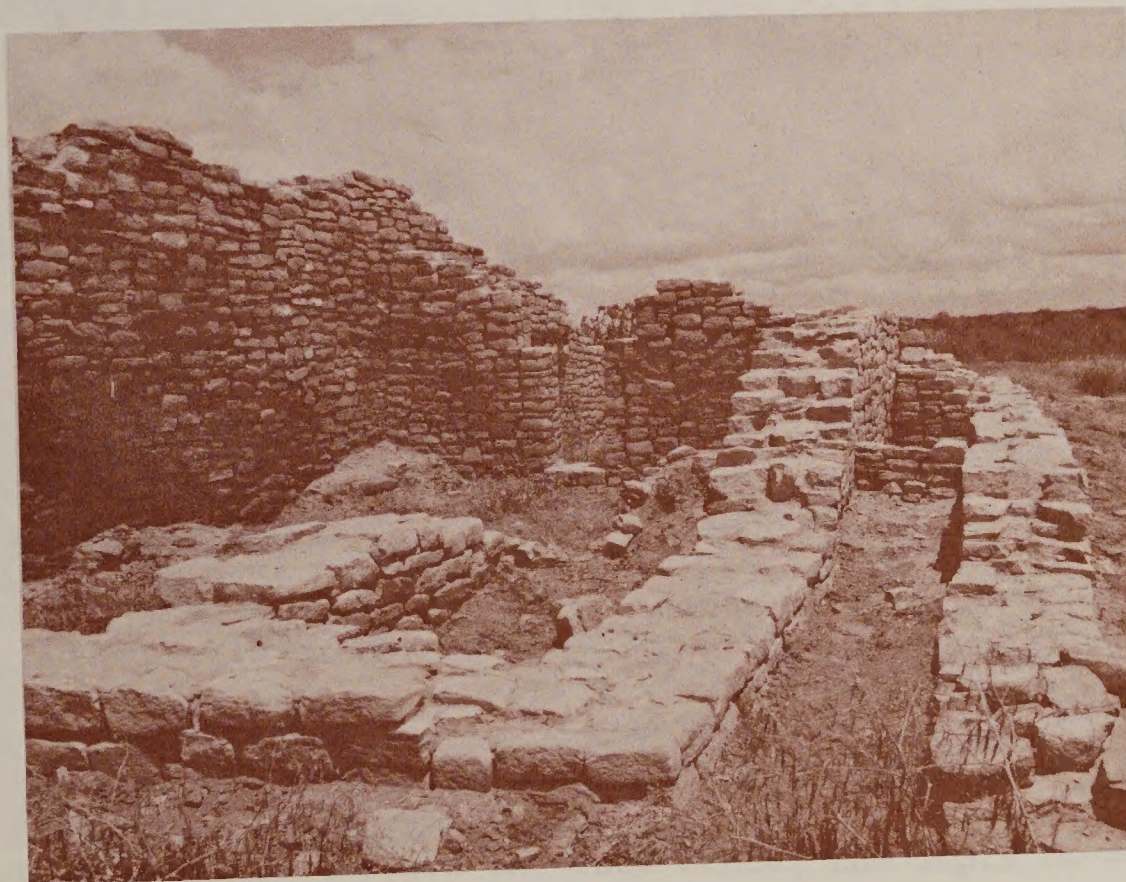
Figure 7. Lowry Pueblo, south end, 1966-67. a, before stabilization; b, after stabilization; Kiva H is not stabilized in this photo.

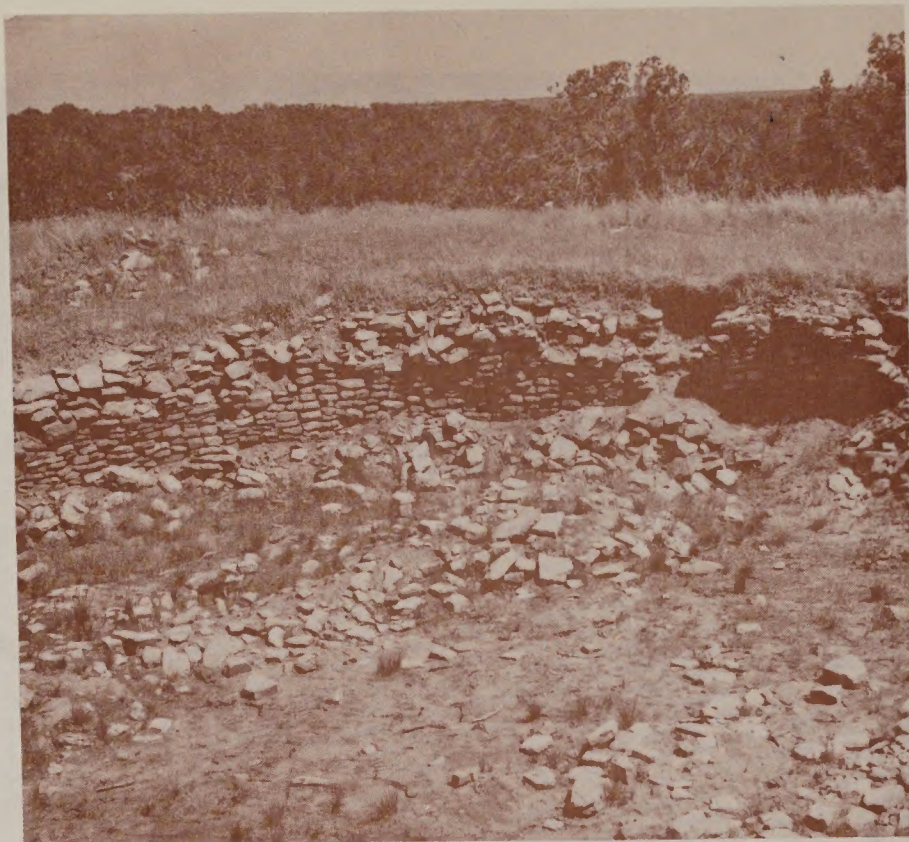
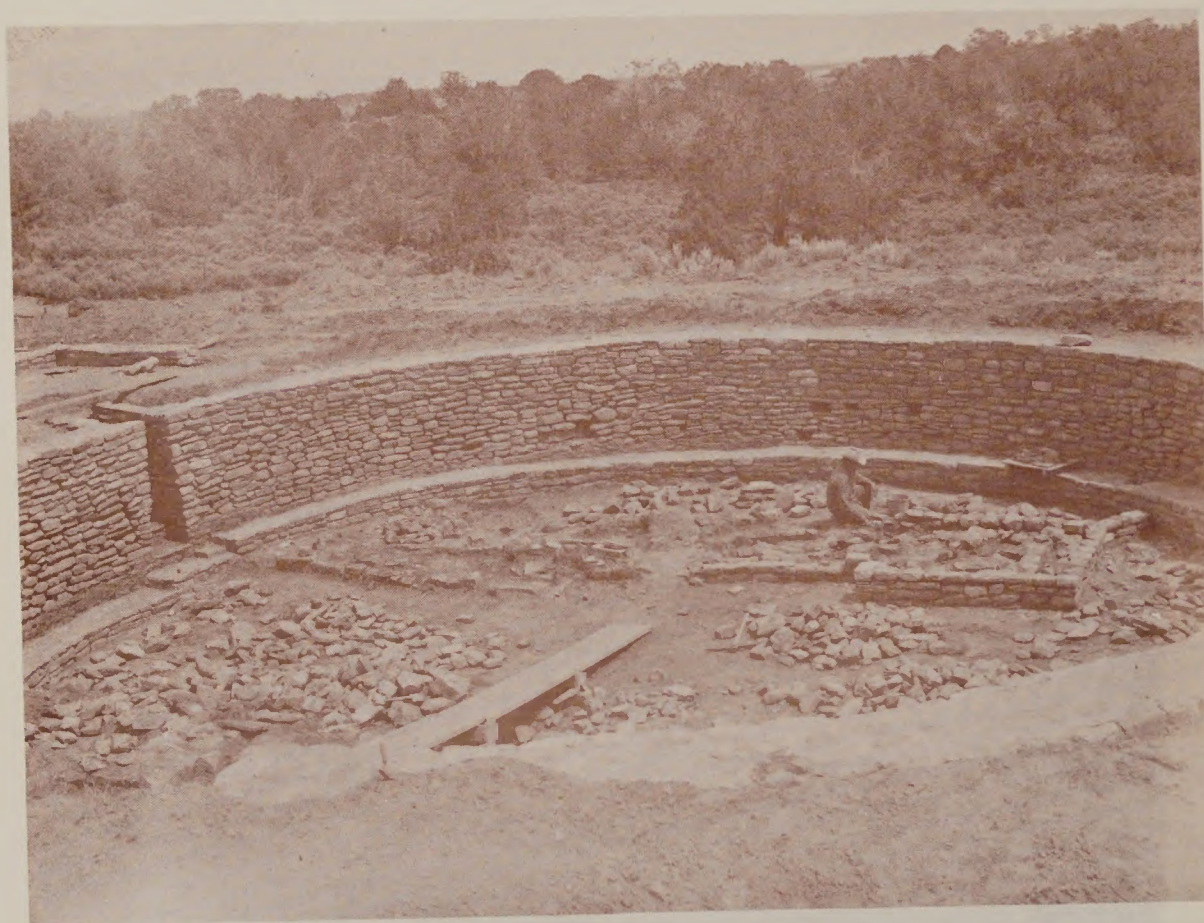
The second season began in June, 1967. The Pueblo was completed and work began on the Great Kiva. The major reconstruction necessary to restore the Great Kiva is seen in Figure 8. Surface runoff down the walls and recessed stairway had caused rapid deterioration.

Figure 8. Great Kiva, 1967. a, southeast view before stabilization; b, east view during stabilization.

The Great Kiva walls were rebuilt to the ground surface with all moisture drained away from the top of the Kiva. All built-in features were repaired, with drainage to the main part of the Kiva. The poles were replaced in the steps. Rooms 1, 2, and 3 north of the Kiva were reconstructed with low walls of several courses (Fig. 9).

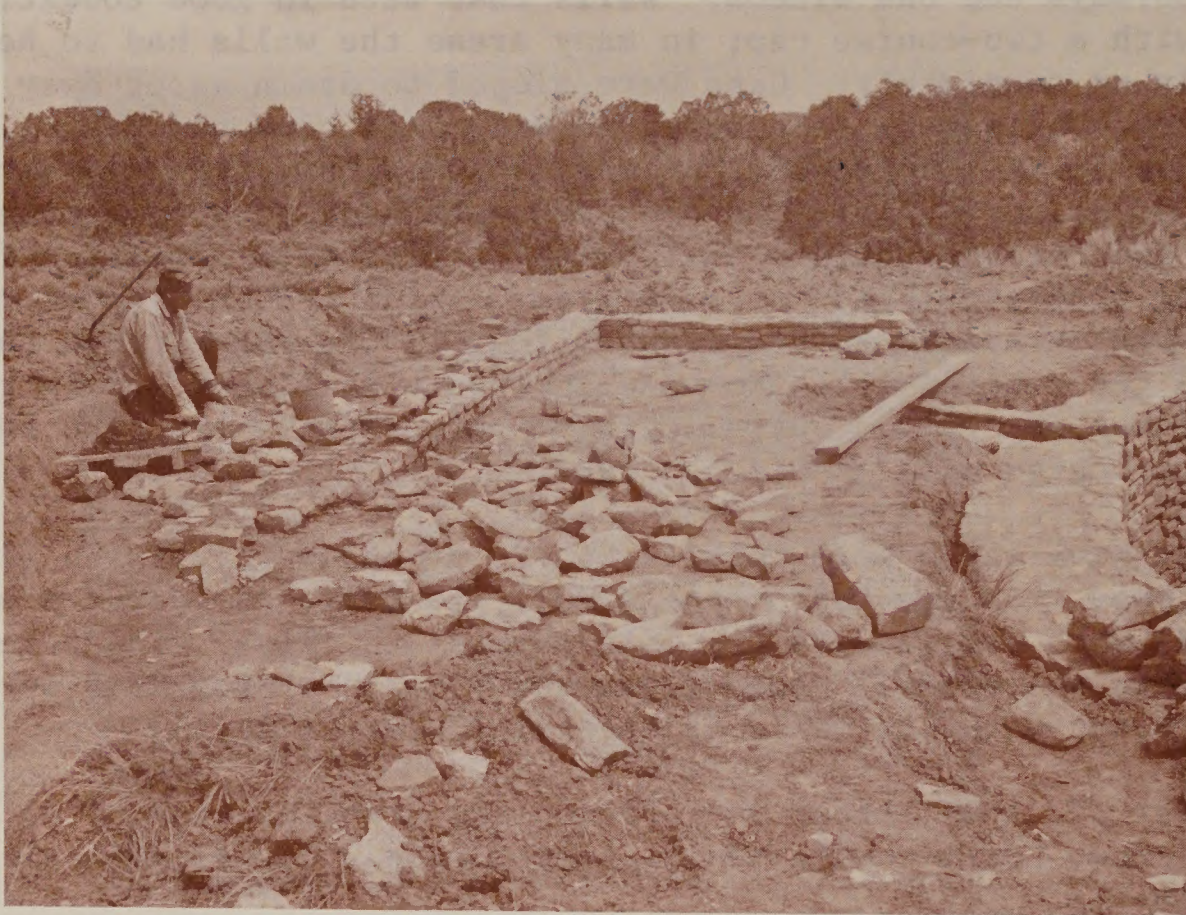
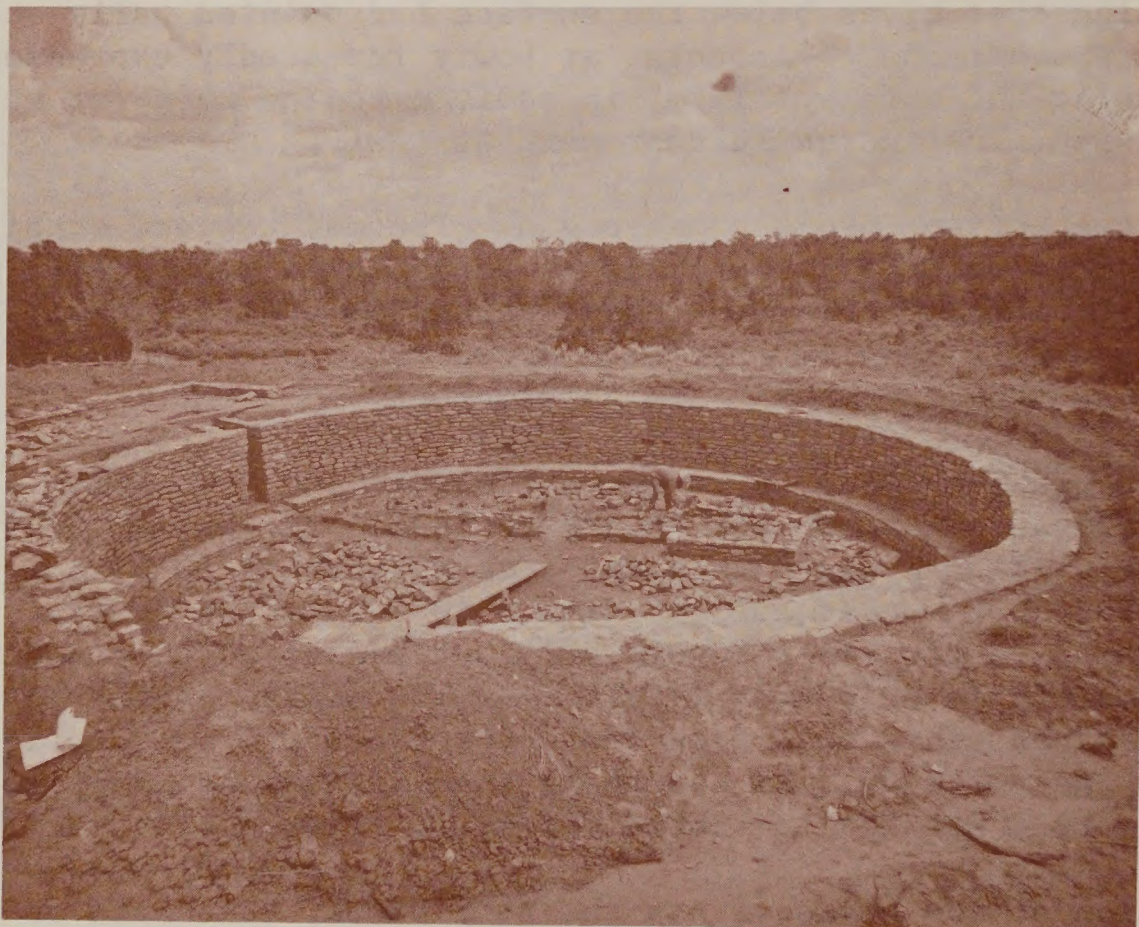
Figure 9. Great Kiva, 1967. a, room block to north during stabilization; b, walls were stabilized higher to the inside to drain water outward away from walls.

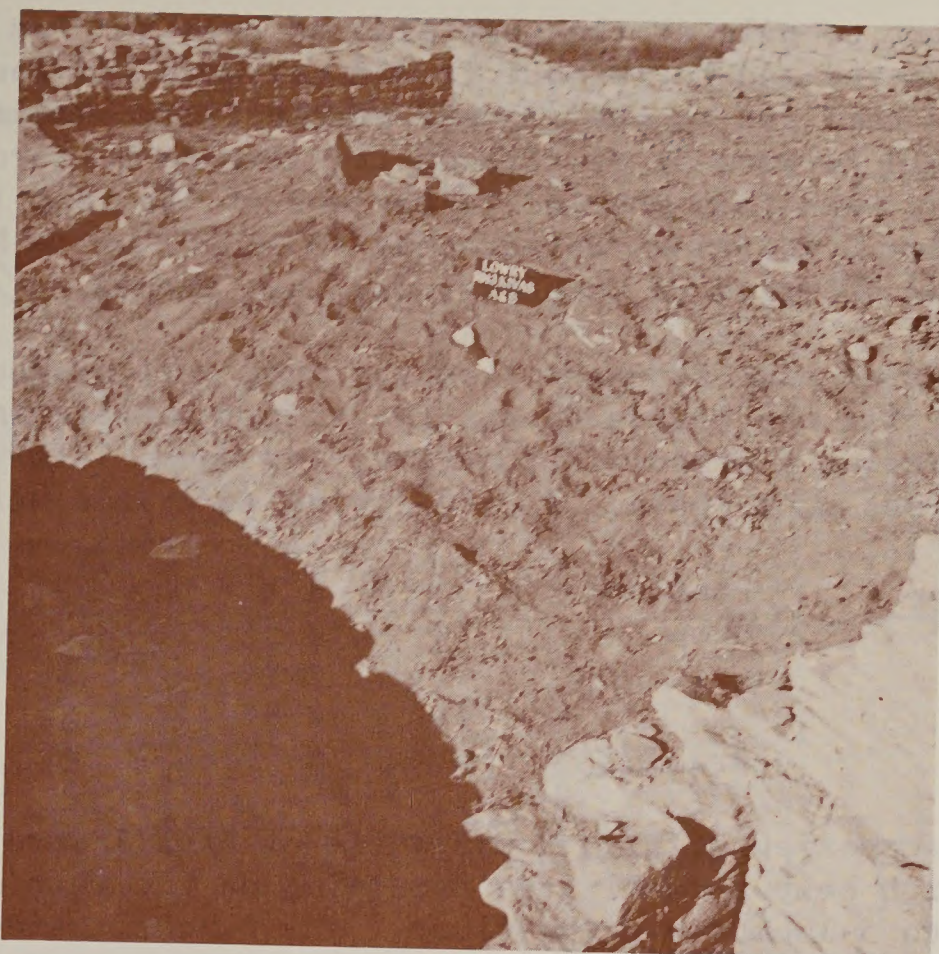
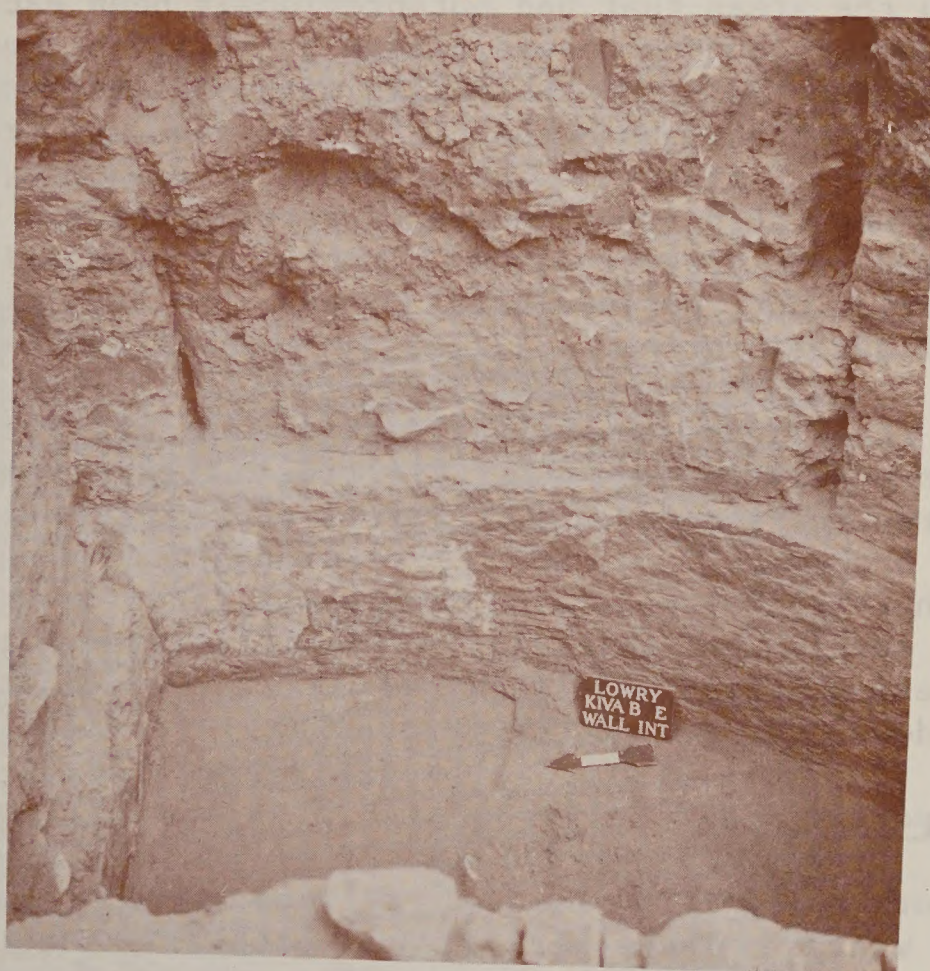
Figure 12. Kivas A and B. a, filled area above kivas before excavation; b, east side of Kiva B excavated to the floor (plaster has slumped off in this area).

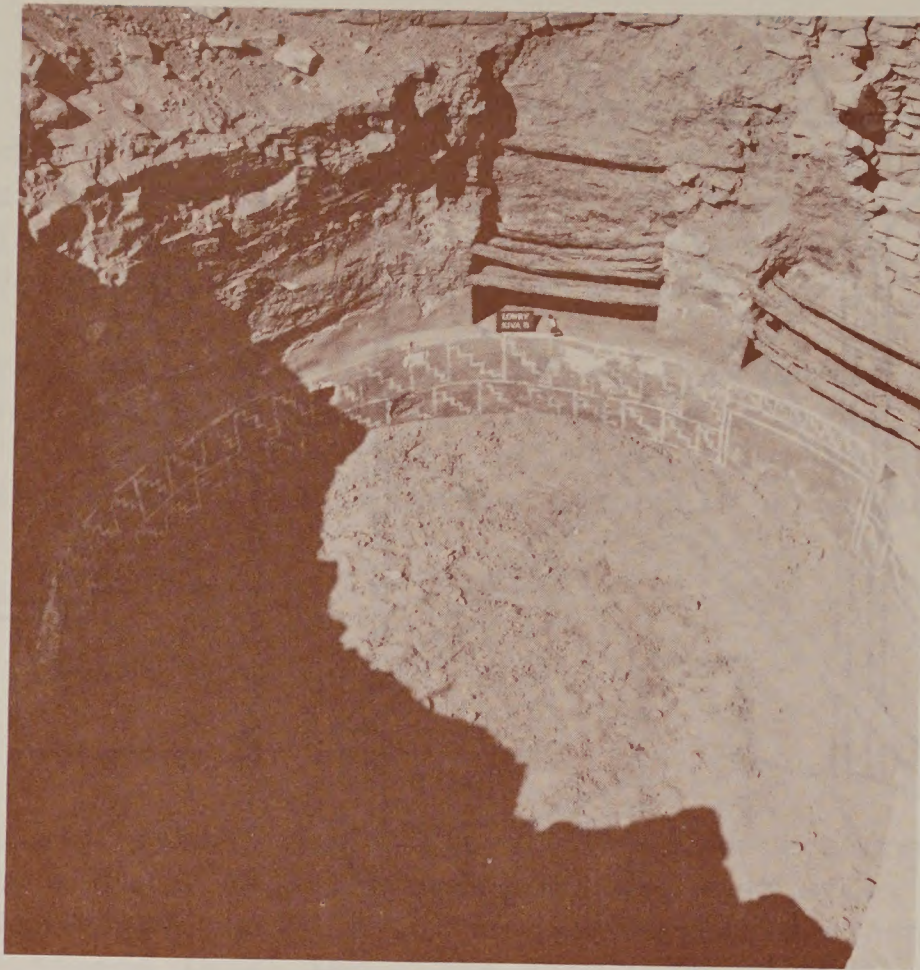
With the excavation of Kiva B the walls of Kiva A were almost completely removed, with only a small area remaining on the west side. Kiva B was excavated to 5-10cm above the floor. The benches were cleaned and the murals were photographed (Fig. 14). The condition of the murals was excellent in the areas that had not previously been excavated. Those areas that were lacquered showed damage primarily between the first and second pilasters. Painting the murals with shellac created a hard frontal surface which caused the plaster to separate from the stone wall and other layers of plaster. The presence of moisture, dirt, and roots behind these separated areas increased deterioration. When these areas were excavated, the plaster either crumbled or gradually began to break down as it dried out; no successful process has been discovered to stop this type of deterioration.

Figure 14. Kiva B. a, north view of murals after excavation in 1974; b, close-up of damaged area where plaster is peeling from the walls.

In order to recover as much of the design as possible, tracings were taken of the murals in sections. The tracings show what design remains, the areas cracked, and in some instances a previous design where the plaster had broken off. Close-up photographs were also taken of the entire bench (Fig. 15). A color sample was taken of the plaster. As soon as the murals were recorded, they were covered with strips of plastic sheeting, which were anchored to the tops of surrounding walls and draped down over the murals (Fig. 16).

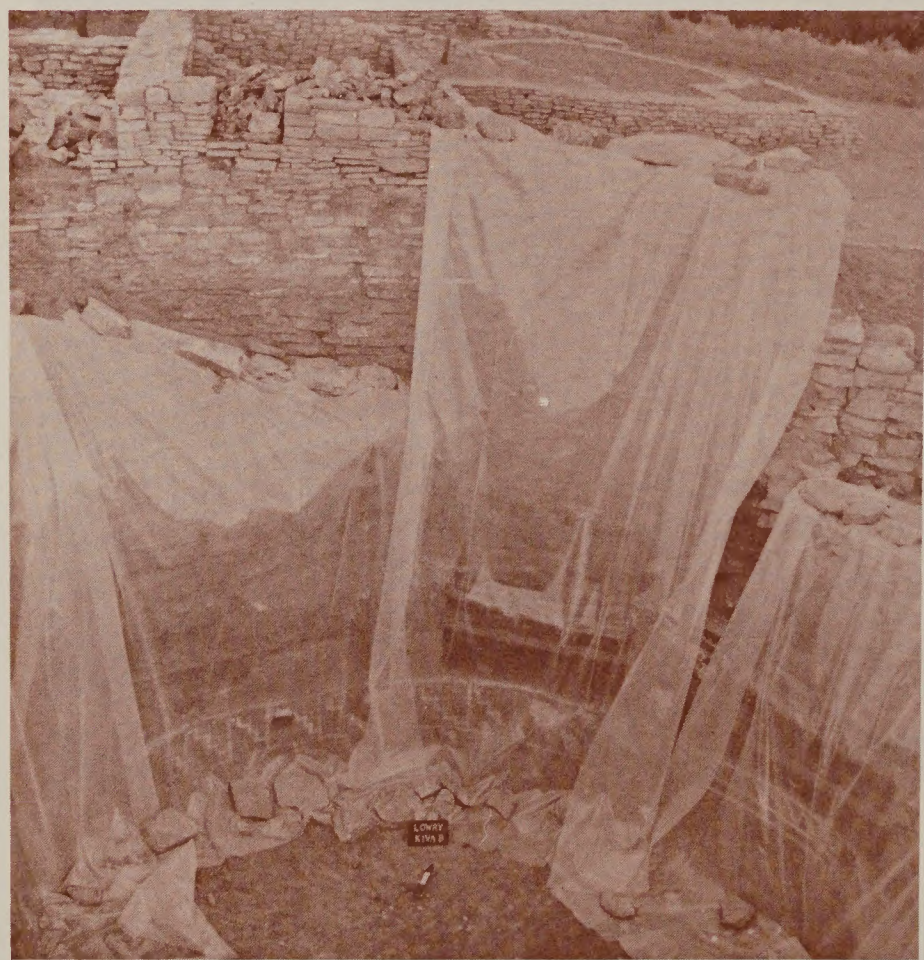
b

Figure 16. Kiva B. a, north-south profile of plastic sheeting over murals; b, north view of plastic sheeting secured with stones to the top of surrounding walls and draped over murals.

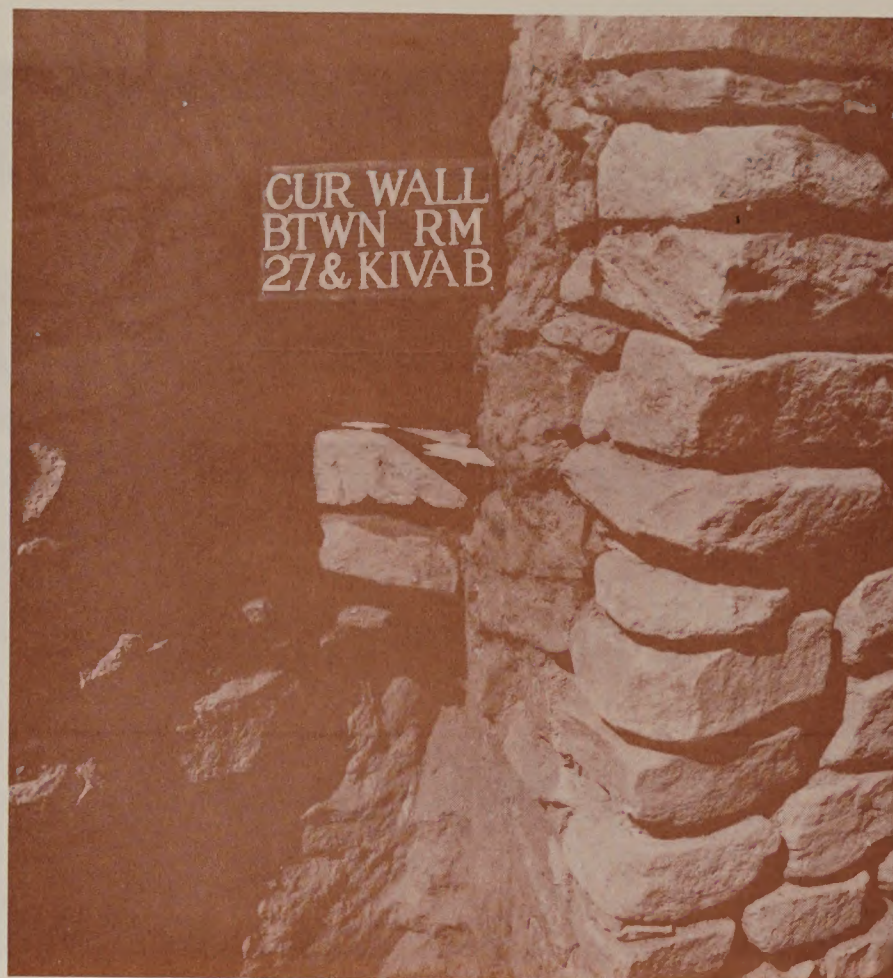
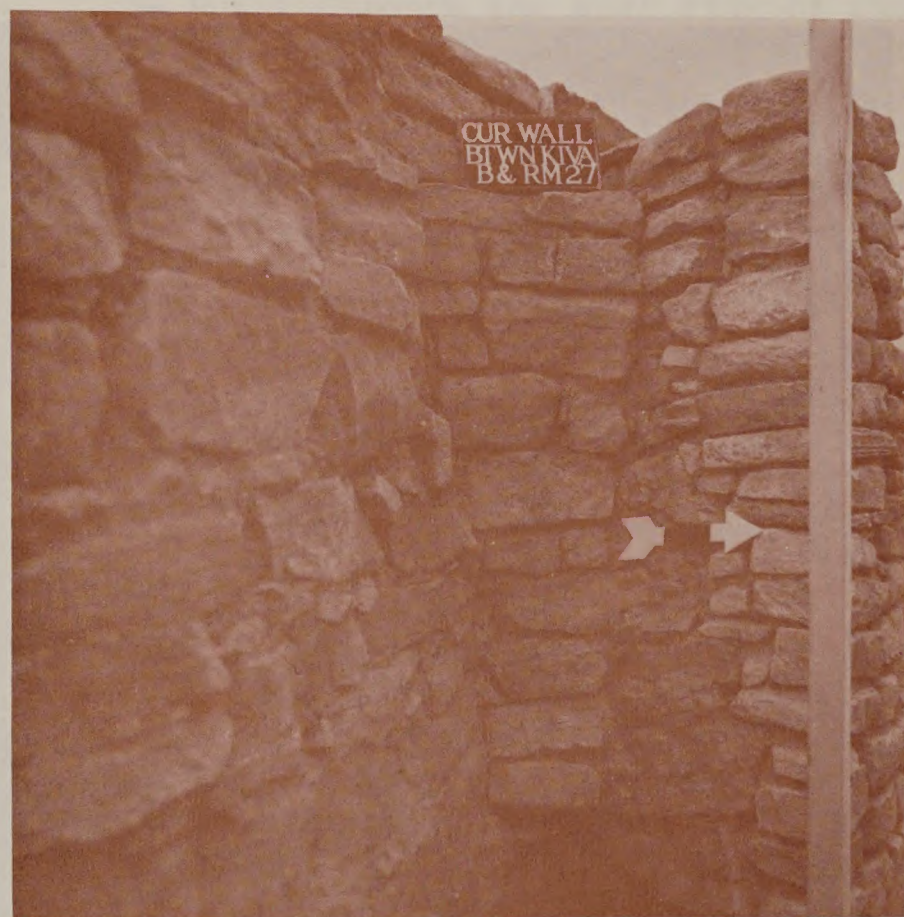
Figure 21. Wing Wall connecting northwest exterior corner of Room 27 and Kiva B. a, fill area before wall was constructed; b, after construction of wall.

The access began at Room 31. Beam steps of 90cm in length by 1.2m in width, on a stone foundation, lead down into Room 31 (Fig. 20). This room and Room 27 were both excavated to a depth of 90-1.2m to provide higher doorways, to lessen accidents. The restoration of the entryway to Room 27 is covered in Report 34. The drainage hole in the north wall of Room 27 was enlarged to create a doorway built with wooden lintels (Fig. 20). This doorway led into the south end of the unnumbered space east of Kiva B. The south end was excavated to a depth of 70 cm with a retaining wall built to hold back the fill of the rest of the area. This wall is 75cm high and spans the distance between the east wall of Kiva B and the west wall of Room 32. A small wing wall was constructed to span the distance between the northwest exterior corner of Room 27 and the exterior southeast wall of Kiva B (Fig. 21).

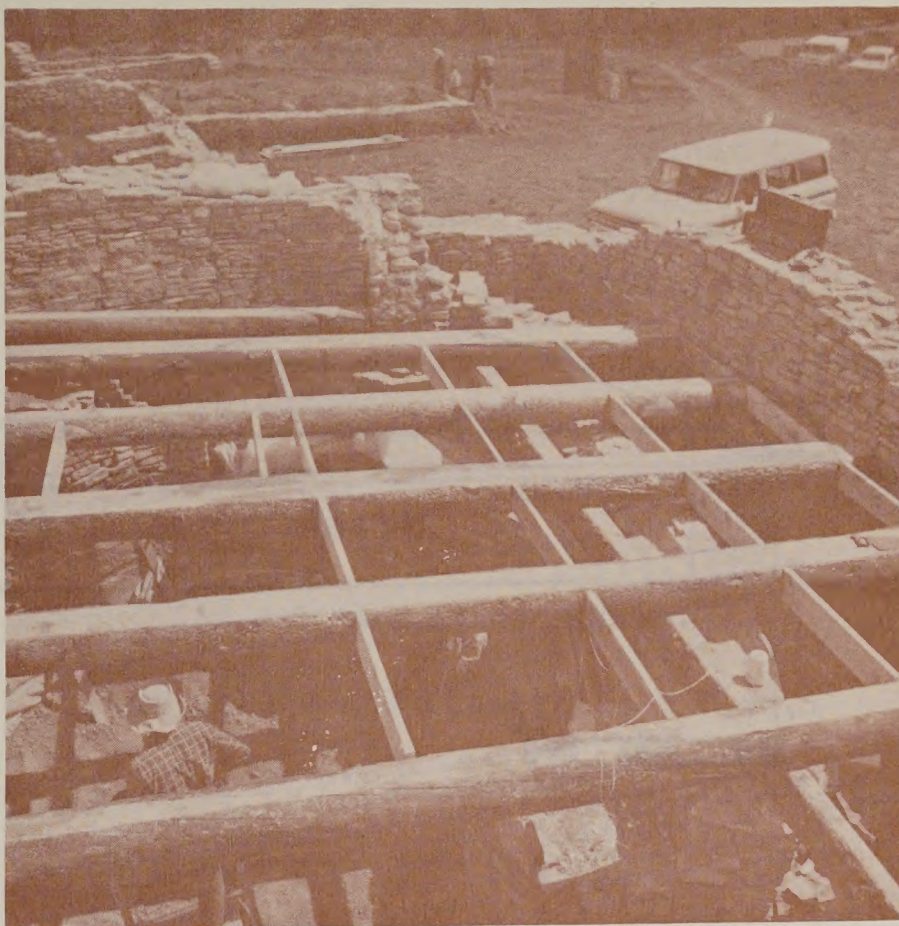
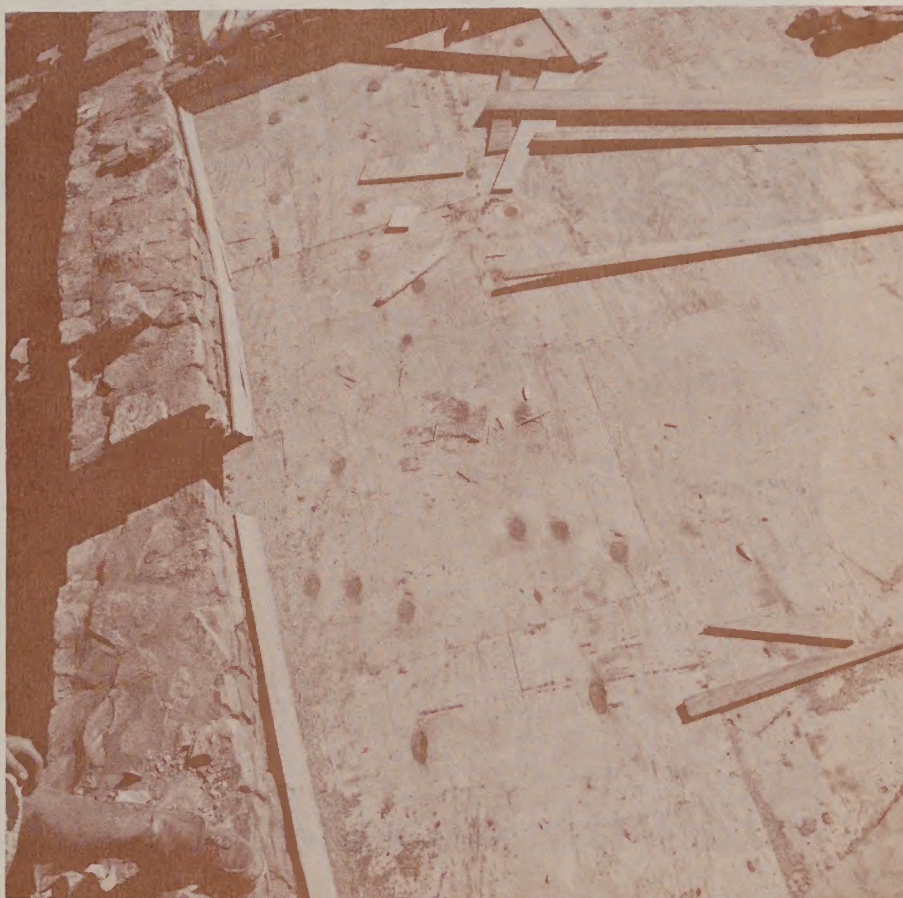
Figure 27. Kiva B, permanent roof. a, north view of roof frame; b, north view of plywood roof and frame nailers.

Rafters: Five 8" x 8" x 34' beams were placed on four-foot centers across Kiva B. The beams rested on the base plates and butted up to the west wall of Room 3 and the east wall of the space east of Kiva B. Two shorter beams were used at the north and south ends across the southern recess and against the south wall of Room 7. The rafters were nailed to the base plates with 1' bridge spikes (Fig. 27).

Frame Nailers: Nailers of 2" x 8" boards were placed in chiseled sockets on four-foot centers between all the rafters (Fig. 27).

Plywood: Sheets of 4' x 8' plywood were nailed to the roof frame lengthwise north-south. The rows were staggered to give the seams more strength (Fig. 27).

Tarpaper Nailers: 1" x 4" boards were nailed around the edge of the roof as nailers for the tarpaper and as additional sealers against moisture (Fig. 27).

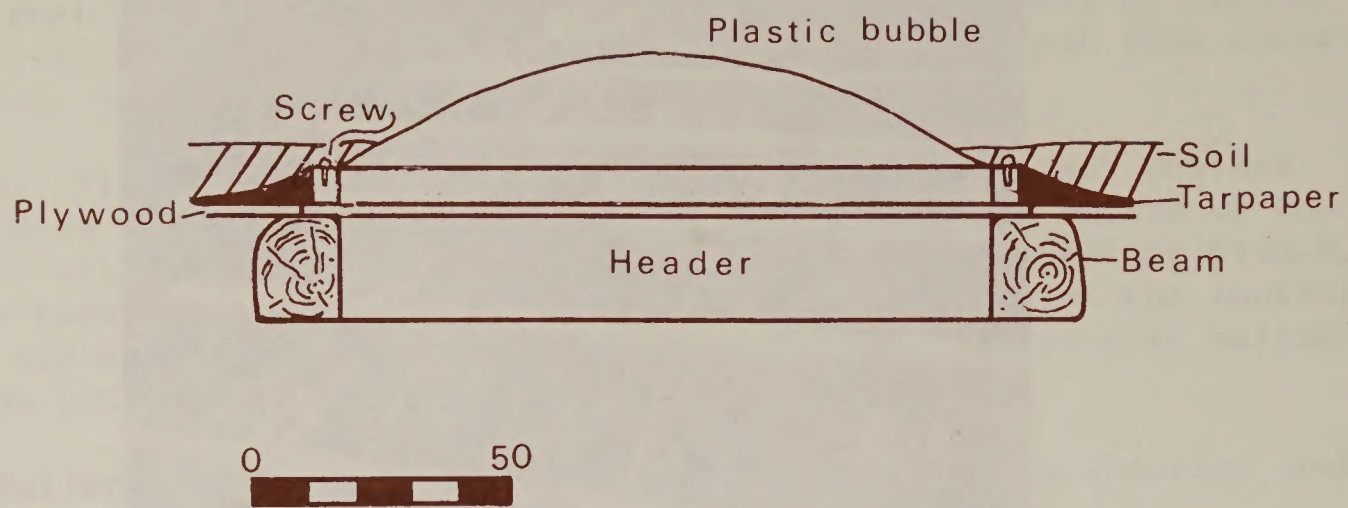
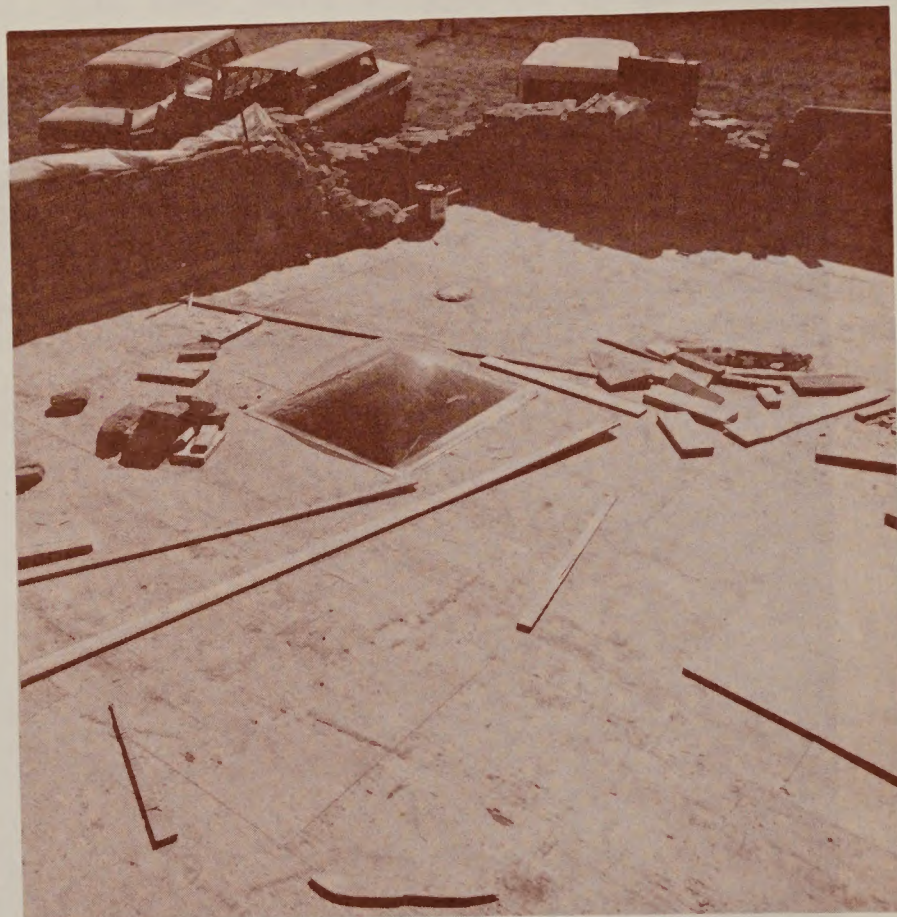
Figure 28. Kiva B, permanent roof. a, profile of plastic bubble; b, northeast view of plastic bubble secured to roof.

Plastic Bubble: A four-foot frame of 2" x 4" was built as a base for the skylight. The frame was secured on top of the plywood. The bubble was then screwed to the frame (Fig. 28).

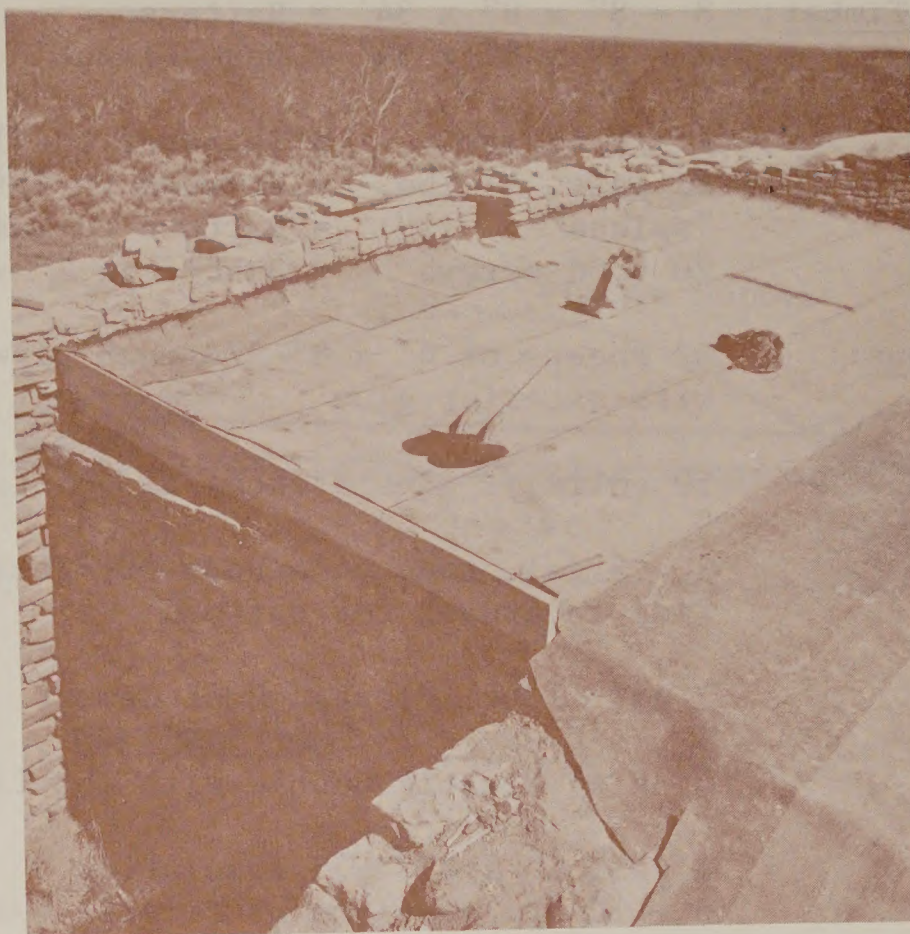
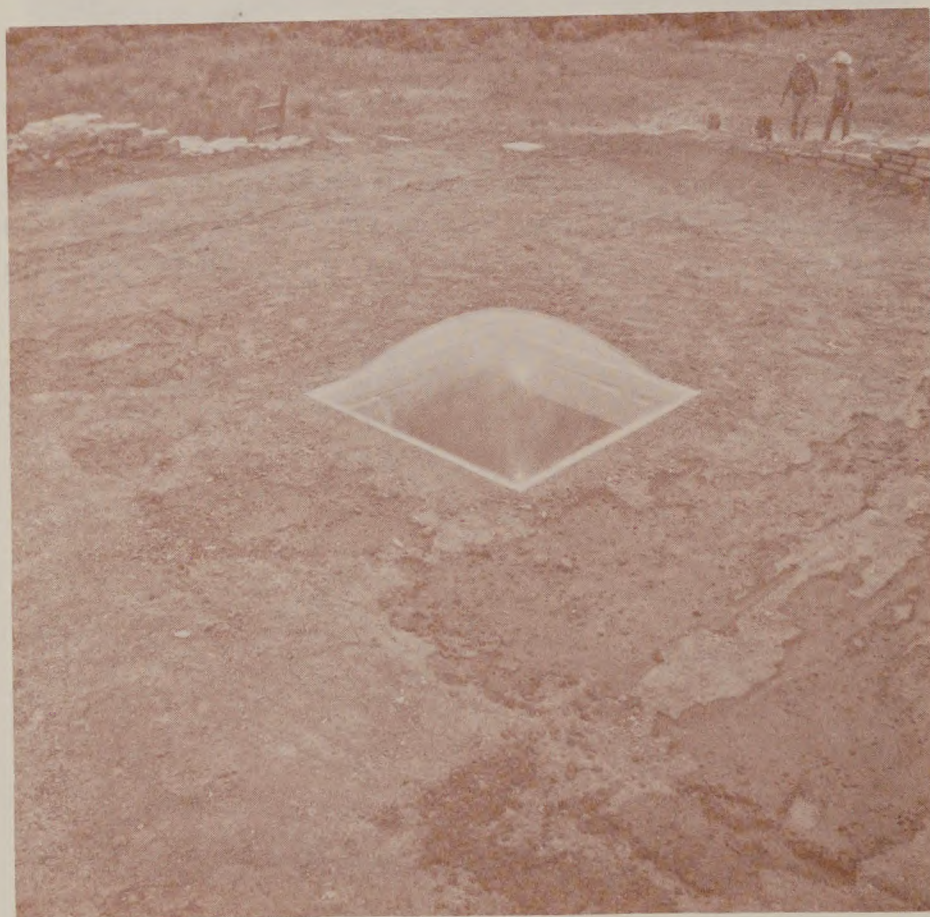
Figure 29. Kiva B, permanent roof. a, north view of tarpaper layer and areas sealed with plastic cement; b, after addition of dirt layer.

Tarpaper: Strips of tarpaper were laid over the plywood and secured to the nailers. Plastic roofing was used to seal the joints around the edges of the roof and particularly around the bubble (Fig. 29).

Dirt: 10-15cm of dirt were put on the roof (Fig. 29). A drainage pipe was screwed with a coupling into the southeast corner of the roof that extended 90-15cm below the surface, made a 90° turn, and extended along the north wall of Room 31 to 8m beyond the Pueblo. A drainage box was placed over the pipe into the roof (Fig. 30). The pipe was wrapped in insulation and the portion left exposed was covered with a plywood box.
